“Full” Reserve Study

Little Elk Creek Village Snowmass, CO

Report #: 28062-0
For Period Beginning: July 1, 2015
Expires: June 30, 2016

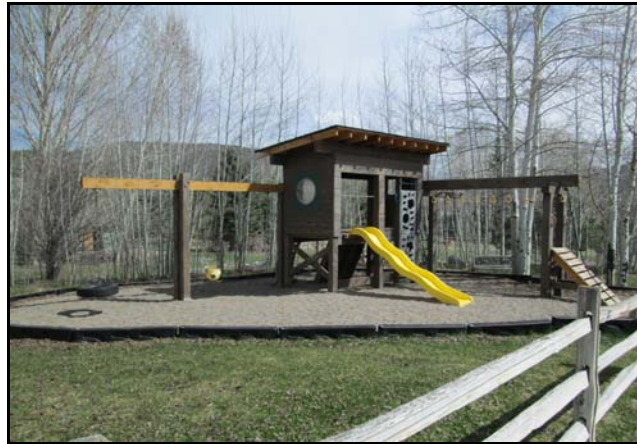
Comp # : 2111 Playground Equipment - Replace

Useful Life:
15 years

Remaining Life:
8 years

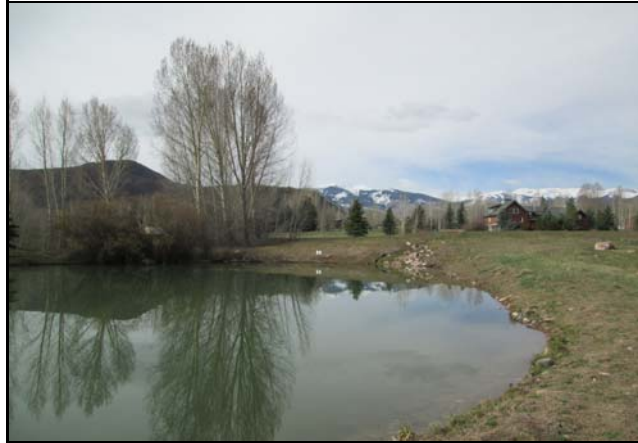
Comp # : 2515 **Water Line - Repair**

Useful Life:
1 years

Remaining Life:
0 years

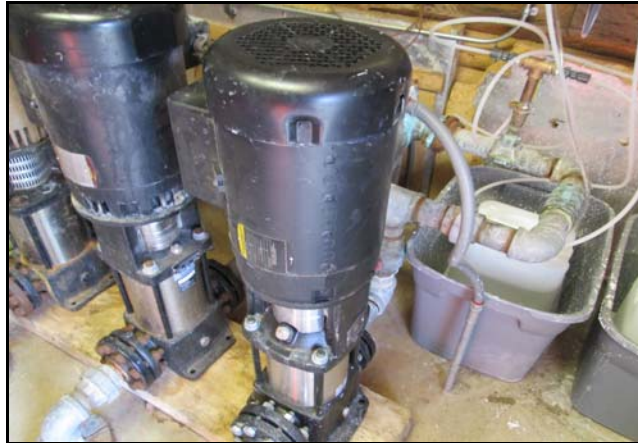
History : Replaced in 2013

Evaluation : Booster pump. (1) Baldor motor/pump. Serial # - F1307030065. Pump systems can have a highly variable life expectancy depending on level of use. Should be inspected regularly and repaired as-needed by serving vendor or maintenance staff to ensure proper function and optimal performance. Minor repairs such as pump motor replacements, electronic system parts, etc. should be considered an Operating expense. Plan to replace the entire system at the approximate interval shown below based on our experience and research with similar systems. Total life span can vary based on level of use, preventive maintenance, quality of materials and installation, etc.

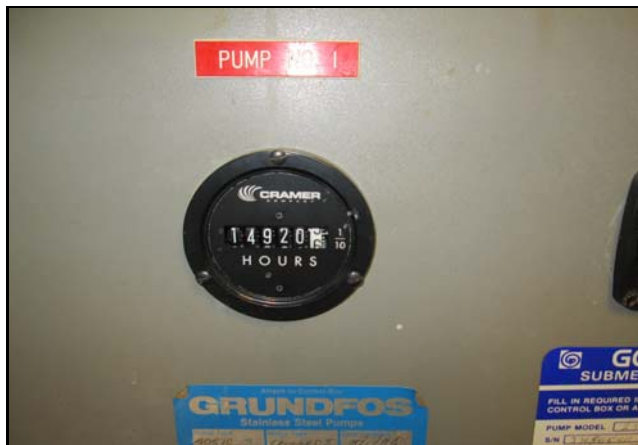
History : Replaced in 2009

Evaluation : Pump was listed to be a 40510-3. The motor/pump was listed to have ~14920 hours. Minor repair and maintenance projects should be included within the association's Operating budget. Have internal components inspected and evaluated regularly by servicing vendor or maintenance staff to optimize performance.
