Little Elk Creek Village
Snowmass, CO

Report #: 28062-2
Beginning: July 1, 2023
Expires: June 30, 2024

RESERVE STUDY
Update "With-Site-Visit"

July 10, 2023

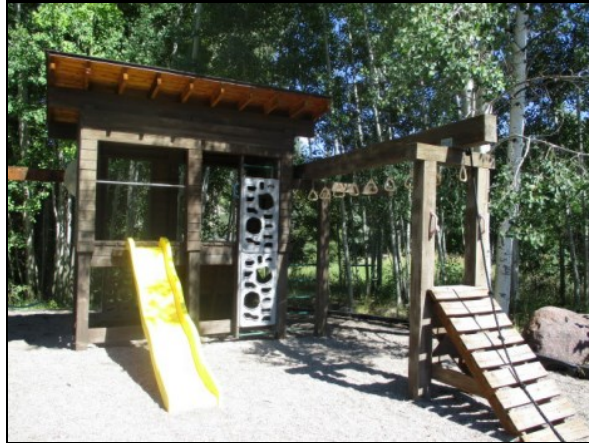
Comp #: 2111 Playground Equipment - Replace

Comments: Reported that the play set has been repaired as needed to extend the life of the unit. No major issues were noted with the equipment at the time of our inspection. Our inspection is not intended to identify any structural or latent defects, safety hazards, or other liability concerns. Funding recommendation shown here is strictly for budget purposes. As a routine maintenance expense, inspect for stability, damage and excessive wear and utilize maintenance funds for any repairs needed between replacement cycles. Life expectancy can vary depending on the amount of use/abuse. Unless otherwise noted, cost estimates assume replacement would be with comparable size and style of equipment as noted during inspection.

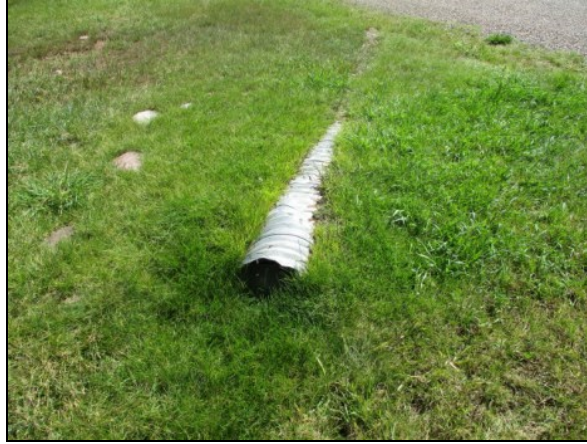
Comments: Various drainage improvements at this site include drainage culverts with no current problems observed or reported. Annual preventive maintenance work is typically performed as part of an association's general maintenance/operating fund. No reserve funding allocated at this time, however, if a pattern of larger expenses develops, we may recommend including a rotating funding allowance for larger expenses during future Reserve Study updates. Maintain records of any substantial projects so that future funding recommendations can be accurately based on recent project history.

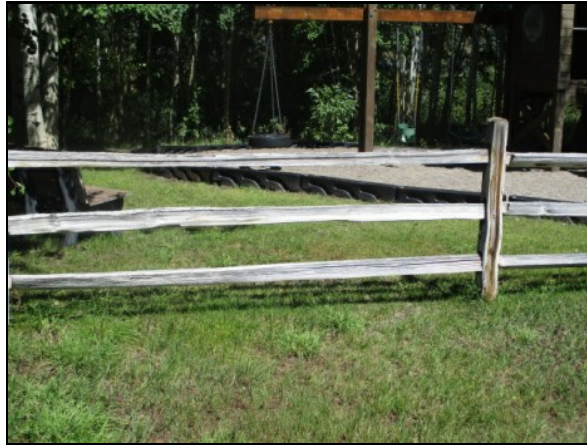
Comp #: 2139 Fencing: Wood - Replace

History: Replaced in 2016

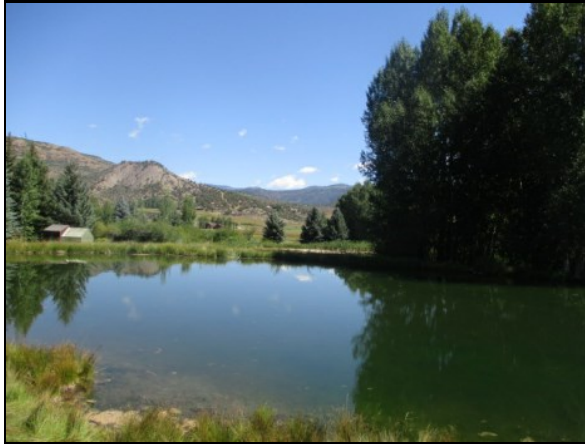
Comp #: 2515 Water Line - Repair

Comments: Current repair allowance based on client estimates from the previous Reserve Study.
